Gauging the tide

A critical review of the current level of methods used to assess and manage flood risk in the Upper Severn Estuary

Advance the Line

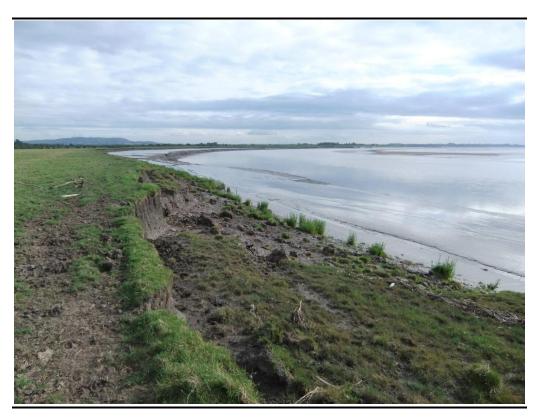
Figure 1.3 Narrow band of saltmarsh on Saul Warth, 8th August 2012

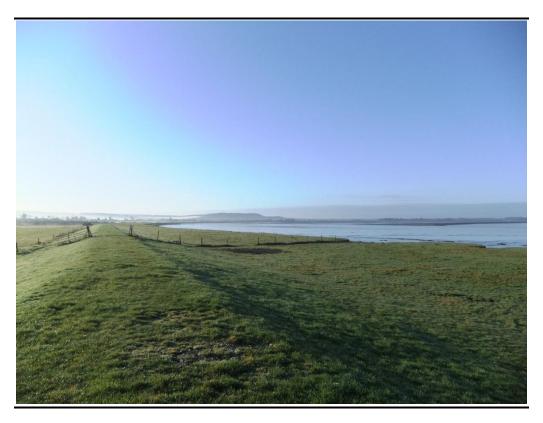
Figure 2.1 The Environment Agency's embankment on Saul Warth is kept clear to aid inspection and discourage mammals and vegetation from weakening the defences, 25th February 2012

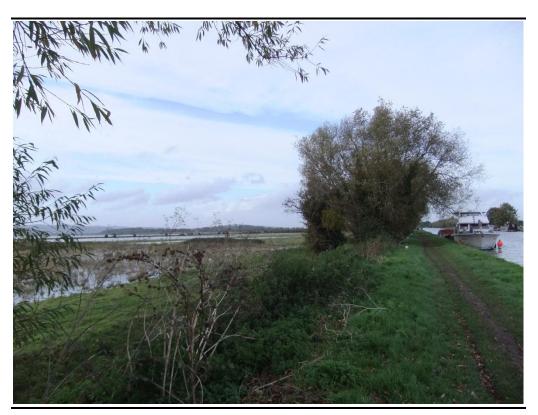
Figure 2.2 The overgrown western canal bank at Frampton, 17th October 2012

Given that the canal bank is almost 200 years old, and that it has only been subject to a visual inspection (which must have been hampered by undergrowth), it is difficult to make any estimate of its suitability as a primary flood defence.

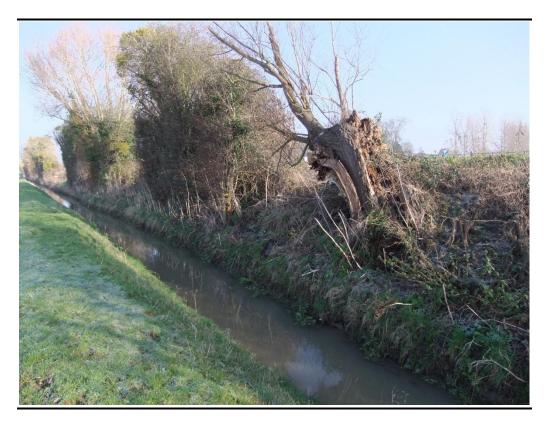
In defining the canal bank as a primary flood defence, no mention has been made of the fact that a primary drainage channel runs at the foot of its western bank. This ditch is owned by the CRT and maintained under contract by the LSIDB, yet no mention of this is made in the *SEFRMS*, nor is it apparent that any discussions have taken place with the LSIDB on the impact of the *SEFRMS*.

Figure 2.3 The primary drainage channel beside the western canal bank at Frampton, 13th January 2013

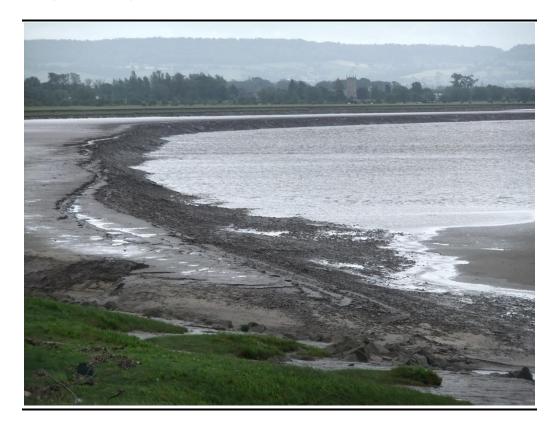
Figure 2.4 The ephemeral high-cliffed mudflat adjacent to Saul and Frampton Warths in a phase of rapid erosion, 23rd June 2012

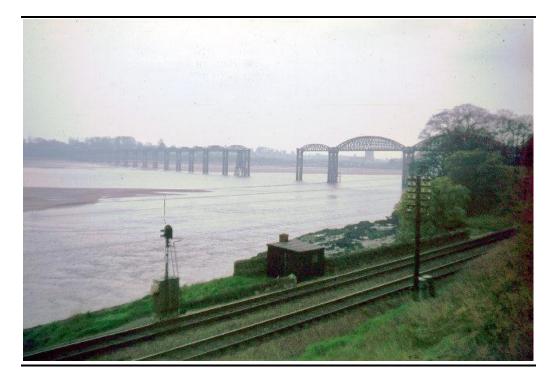
Figure 3.1 Severn Railway Bridge from the western bank after the disaster in 1960¹

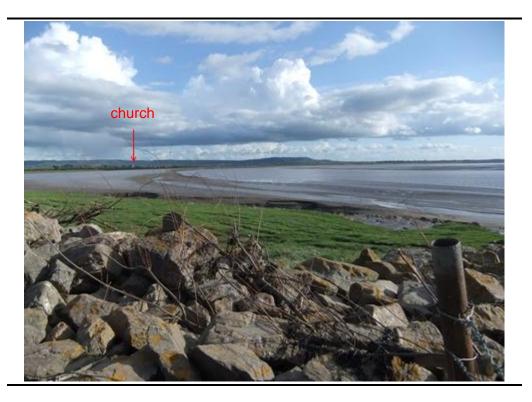
Figure 3.2 Mudflat looking from Fretherne Warth, 10th April 2012

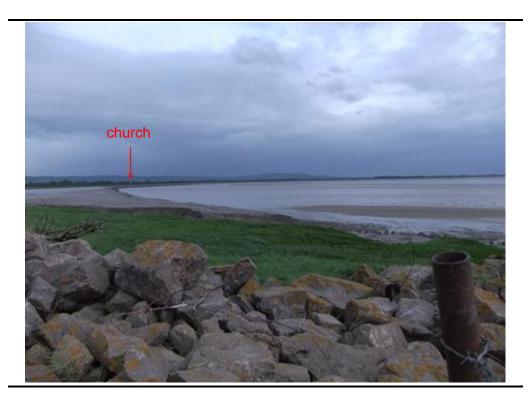
Figure 3.3 Mudflat from the same position immediately after the storm, 8th June 2012

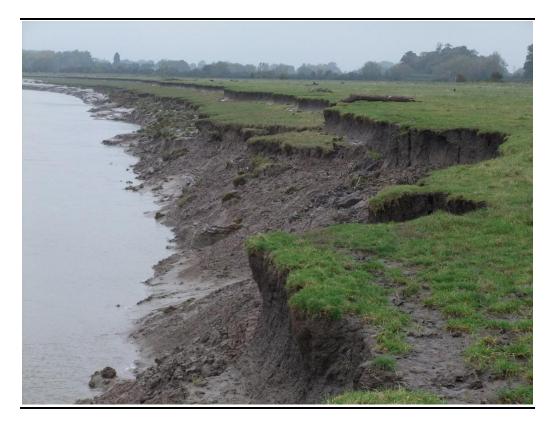
almost impossibly narrow band which is not replicated anywhere else within the estuary.¹ As a consequence it has generally been erroneously thought that the different ground levels within this band have indicated previous extents of erosion.

Figure 3.4 Narrow band of saltmarsh on Saul Warth, 24th October 2012

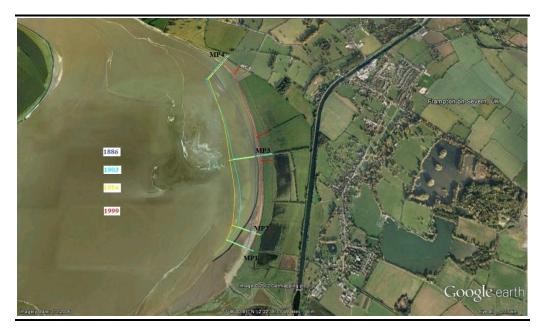
Four Monitoring Points (MPs) were chosen for the purposes of this study and these are shown in Figure 3.5, together with the approximate edge of the warth in 1886, 1903, 1954 and 1999.¹

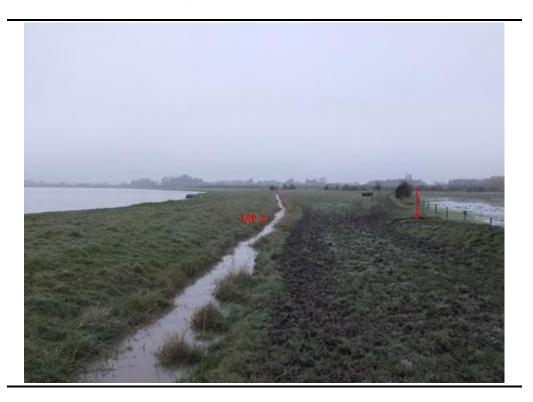
Measurements taken on site in November 2011 and November 2012 give rise for concern, particularly at MP 2 which is only 4.00 m away from a large breach in the old sea wall and interestingly the area most at risk during the erosion cycle of the mid-19th century. At this point the outer warth (currently 12.90 m in width)² is eroding at more than 2.00 m per annum. A few metres north of MP 2 the outer warth is just 10.40 m wide.

Figure 3.9 Monitoring Point 2 at high tide, 15th November 2012 (arrow marks the breach in the old sea wall).

The height of the outer warth increases over time as layers of silt are deposited by the tides. At MP 2 the outer warth is 8.75 m AOD, some 0.75 m above Great Narles, the adjacent field between the old sea wall and the Gloucester and Sharpness Canal. The study undertaken in 2010 by WWT Consulting incorporates a LiDAR survey (see Figure 7.1) which illustrates that a water level of 8.25 m AOD would flood much of the site if there was open connection with the river. Based on the current pattern of erosion this could happen within the next 5-10 years.

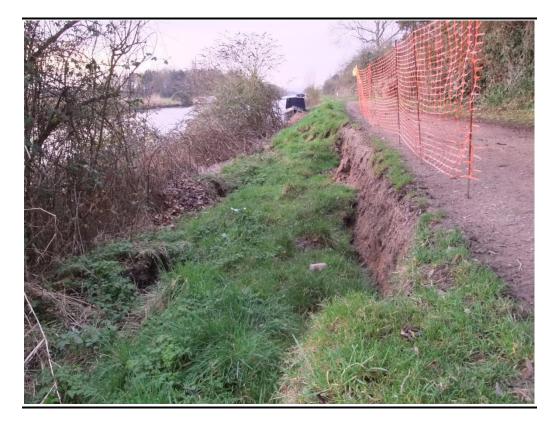
embankments, has led to a number of failures along the canal banks where the integrity of the sheet piling and waling beams have been compromised under the load exerted.

Figure 6.1 Canal bank slippage near Saul Lodge, Fretherne, 8th January 2013

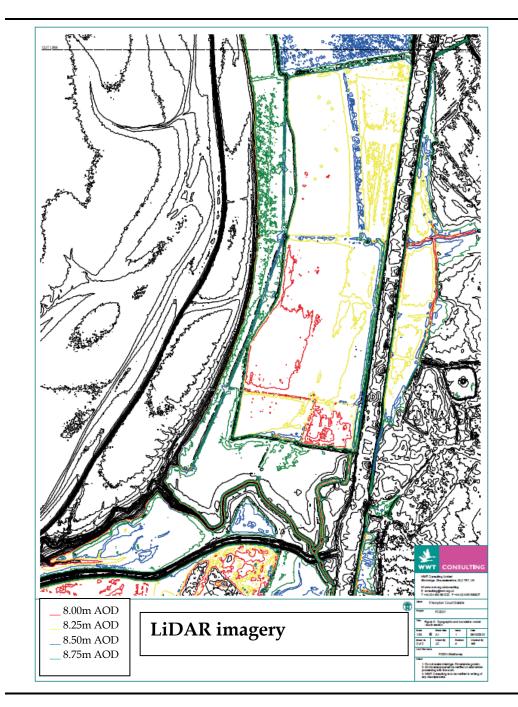
The LiDAR data supplied within the WWT Consulting study is of particular interest as it provides the most accurate indication available of the extent of likely tidal inundation. The southern half of the site is represented in Figure 7.1 which clearly shows the difference in height between the narrow outer warth (8.75 m AOD) and the adjoining low-lying field (variously 8.00 m and 8.25 m AOD).

Figure 7.1 LiDAR data for Frampton Warth

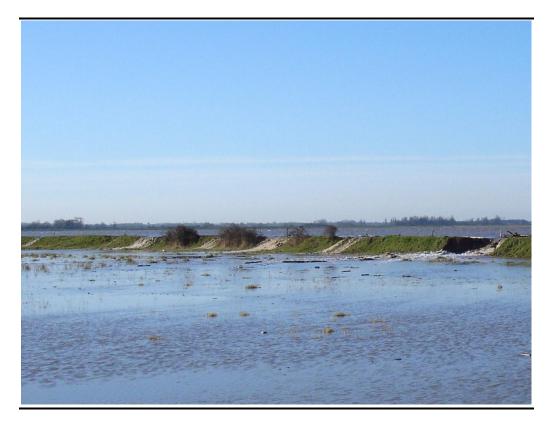
Figure 7.2 Tide topping and breaching the abandoned sea wall on Frampton Warth, 2nd March 2006

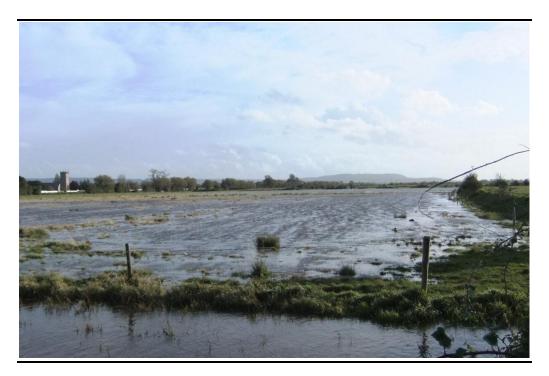
Figure 7.3 Extent of inundation 6 hours after high tide, 17th October 2012
